Change in Appearance of Analog Monitor Connectors and Monitor Cable Connectors for General-Purpose AC Servo Amplifiers

Servo amplifier: MR-J4-A series
Monitor cable: MR-J3CN6CBL1M

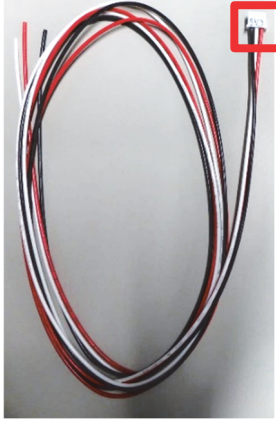
The parts of the analog monitor connectors (CN6) and the monitor cable connectors for servo amplifiers, shown in the red frame in the figure below, will be changed. The existing servo amplifiers and monitor cables will fit into the changed analog monitor connectors and monitor cable connectors properly.

Servo amplifier	Analog monitor connector (CN6)		Monitor cable	Connector for CN6	
	Before change	After change		Before change	After change

Pitch: 2 mm

Housing: 51004-0300 Terminal: 50011-8100 (Molex, LLC)	Housing: 2015S030000 Terminal: 2015TPB0000 (LEOCO)

Two projections

One projection

* The photo above shows MR-J4-10A.

This change will be made sequentially from the January 2025 production. There may be cases where both the former and new products exist in the distribution stage.
